**ITUANGO HYDROELECTRIC POWER PLANT
COLLAPSE OF THE AUXILIARY DIVERSION TUNNEL
CONSTRUCTION ALL RISK POLICY No. 2901211000362
ROOT CAUSE ANALYSIS**

August 2, 2019

Subject Matter: This root cause report pertains to the Ituango Hydroelectric Power Plant, Antioquia, Colombia, that was under construction when the Auxiliary Diversion Tunnel collapsed. The event was recorded as April 28 to 30, 2018.

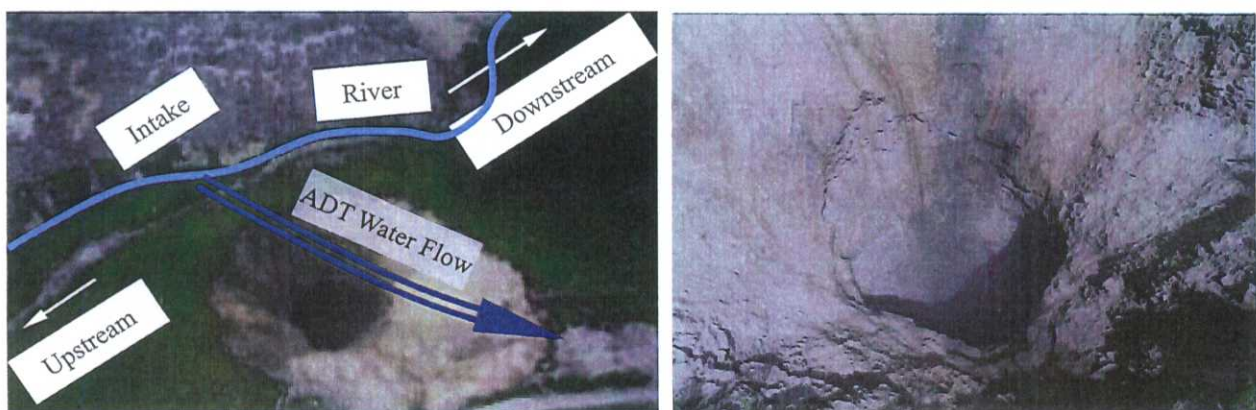
Figure 5. Aerial view of the sinkhole that appeared on April 30, 2018 above the ADT

2.9. On April 28, 2018 the ADT collapsed near the intake portal, ground vibrations were recorded by a local network of seismographs, and workers on the reservoir described a wave and air emanating from the ADT intake portal towards the reservoir. The collapse progressed and ultimately “daylighted” on April 30, 2018, as a 100m wide sinkhole that blocked the tunnel, causing unplanned impounding of the river (Figure 5).

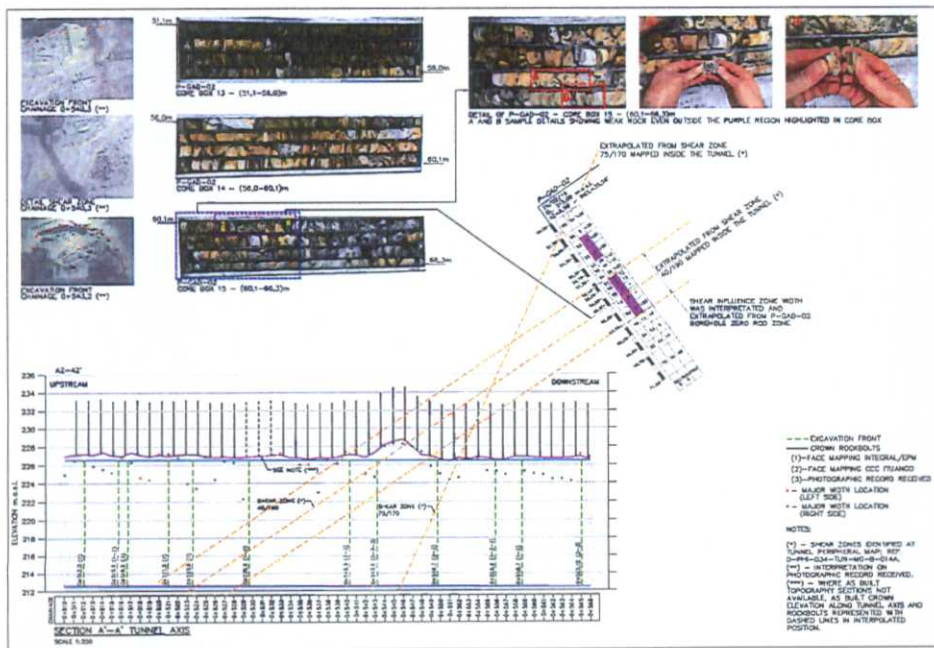
Figure 12. Figure showing Experts projection of shear zones in the P-GAD-02 core to ADT tunnel horizon.

- 6.3. A shear zone was mapped in the Tenche river valley⁴³ during the construction work orientated at 70° / 170° to 180° which was further investigated by a borehole P-GAD-02 in March 2016. Figure 10, Figure 11 and Figure 12 show the location of the borehole P-GAD-02 and the alignment of the ADT, the geological cross section with the projection of the shear zones identified in the borehole to the ADT tunnel horizon, and the photographic record of the shear zone in borehole P-GAD-02 as it reaches the excavation of the ADT. This is the shear zone that is at the location of the collapse.

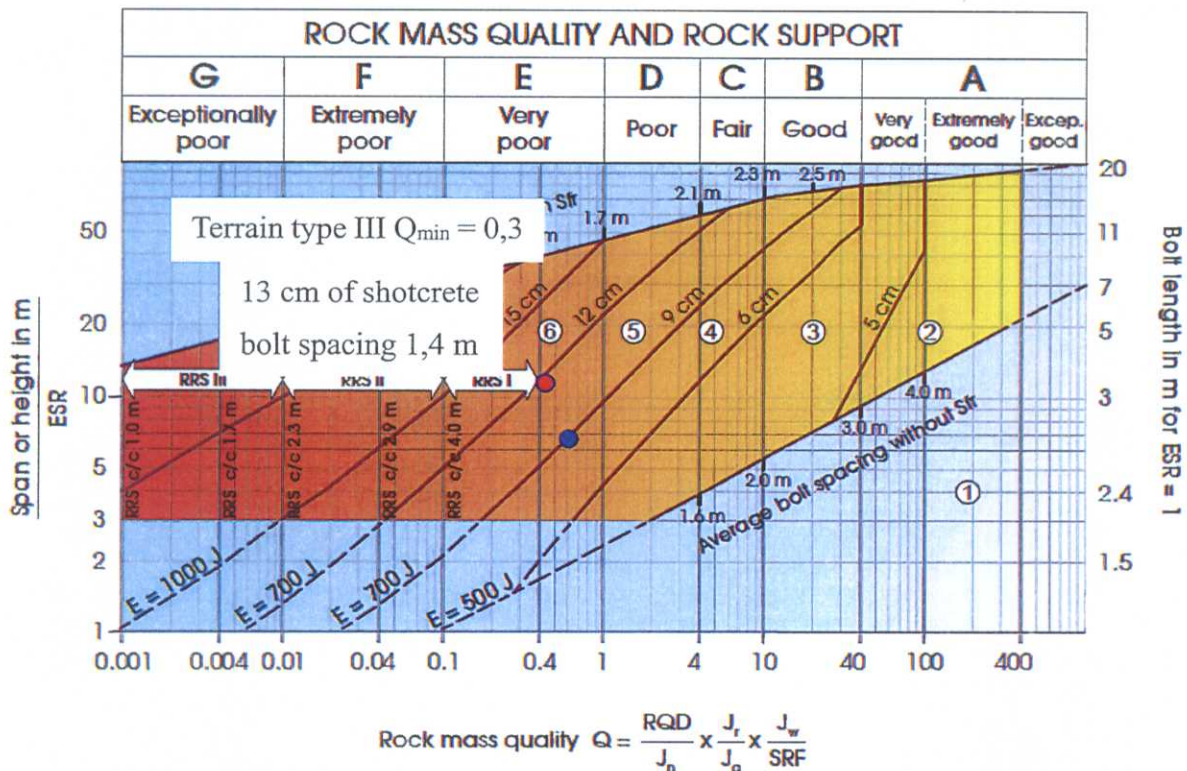
Figure 18. Diagram showing the different support selection for the design Q (blue dot) versus the minimum Q (red dot)

7.25. However, the support shown on the ADT design drawings¹¹⁵ was not based on the minimum Q value of the range for each terrain types. A consequence of this was that the preliminary selection of support was lighter than recommended by this method for the lower part of the range. Using the minimum Q value of a range is normal industry practice.

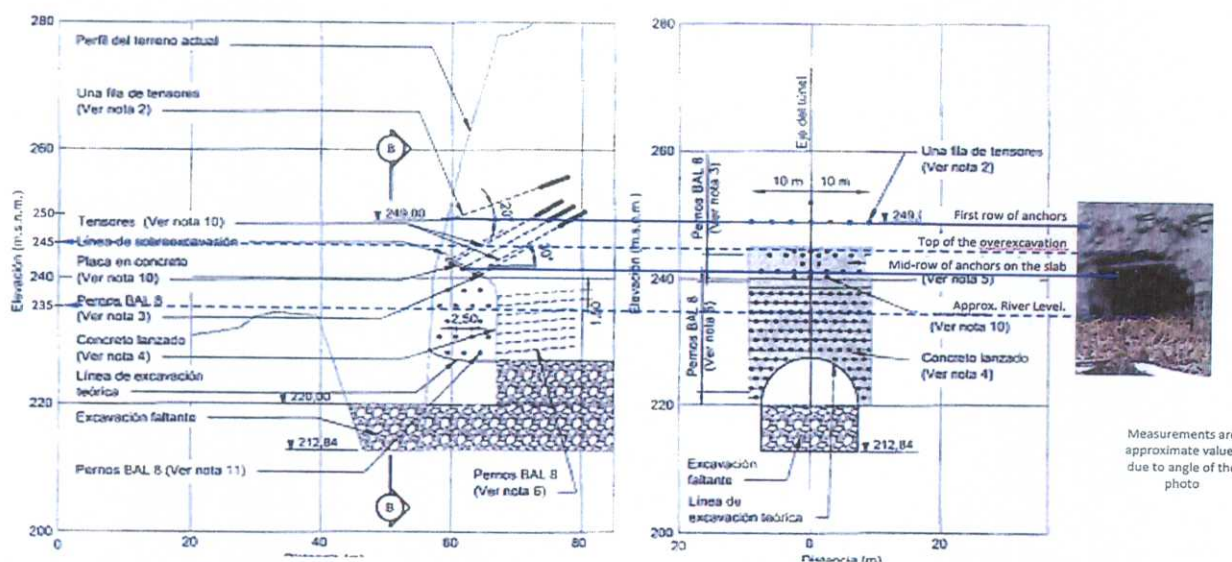
Figure 29. Accumulation of tree logs on days prior to April 28, 2018

design drawings of the ground reinforcement at the ADT portal¹⁹¹ to the photographic record. The composite on Figure 29 indicates the reservoir level on the days prior to April 28, 2018 was about Elev. 234 - 235 masl, which coincides with the data from Figure 28, and is 6 to 7 m above the crown of the ADT portal. The floating tree logs at this minimum reservoir level are above the crown of the ADT portal, and the reservoir level did not drop below the crown (Figure 28) such that floating logs could enter the tunnel. Furthermore, there are no records provided of failure of the mesh at the time allowing tree logs to flow rapidly and in large quantities into the ADT.

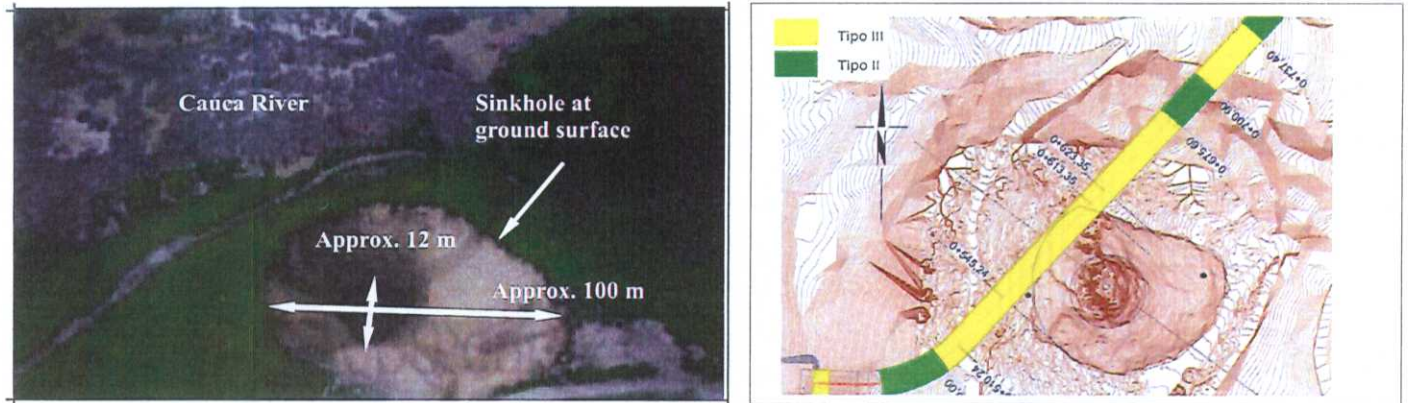
Figure 37. View of the sinkhole at the ground surface April 30, 2018

100 m in diameter narrowing to about 12m in its interior appeared at the ground surface above the ADT²¹⁰ (Figure 37, Figure 38, Figure 39²¹¹). Reservoir levels began to rise from 13:00 hrs. onwards.

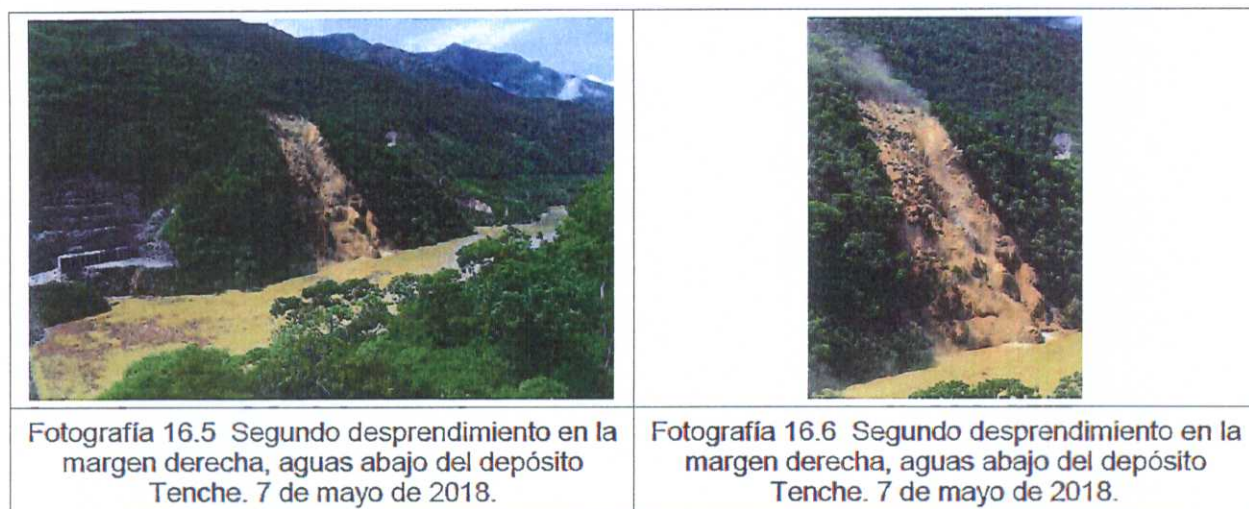
Figure 42. Landslide on the right bank of the river May 7, 2018 ²¹⁹

9.17. On May 7, 2018 there was a landslide on the right bank of the river which further reduced discharge from Discharge Tunnel 4 exit portal and which also covered the two branches of the RDT (Figure 42).²¹⁷ The slope above the access portal to Galleria 1 was also affected, and there may have been a collapse of Galería No. 1 at the intersection with Galería No. 4.²¹⁸ A release of energy was recorded at 01:29 hrs.²¹⁸ Flow recorded downstream, at Puerto Valdivia reduced from a peak of 1,516 m³/s at 20:45 on May 6, 2018 to a low of 120 m³/s by 18:00 hrs. on May 7, 2018 before starting to rise again to 278 m³/s by 23:00 hrs.

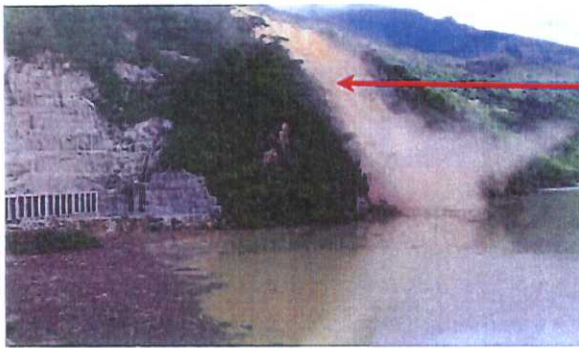
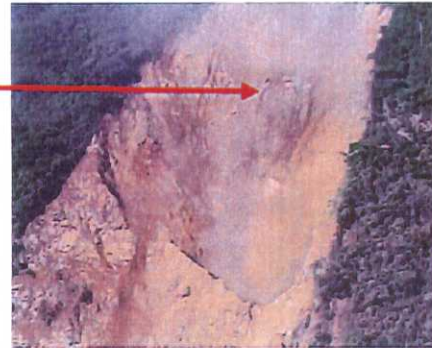
Figure 43. Landslide and sinkhole above Gallerias 1 and 4 May 9, 2018²²².

Fotografía 16.7 Activación del derrumbe inicial generando un nuevo desprendimiento de material en la margen derecha. 9 de mayo de 2018.

Fotografía 16.8 Activación del derrumbe inicial generando un nuevo desprendimiento de material en la margen derecha. 9 de mayo de 2018.

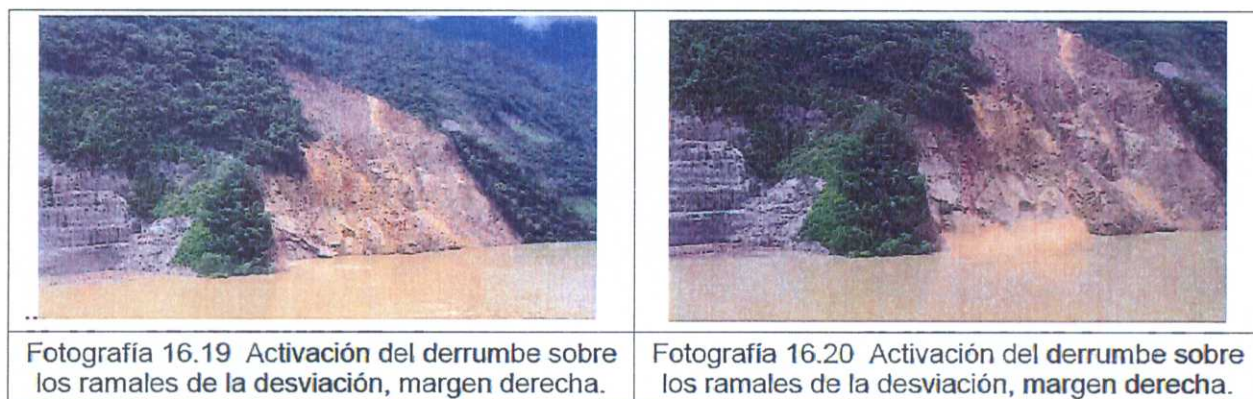
Figure 49. Reactivation of landslide above the Diversion tunnel intakes May 21, 2018²³⁷

- 9.26. On the morning of May 21, 2018 the landslides above the diversion tunnel intakes and above the Gate Chamber Platform re-activated and cracks formed in the Gate Chamber (Gates 5 to 8) and the associated Construction Galleries (Figure 49)²³⁴ and water continued to flow through the RDT outlet portal at about 50 m³/sec²³⁶.

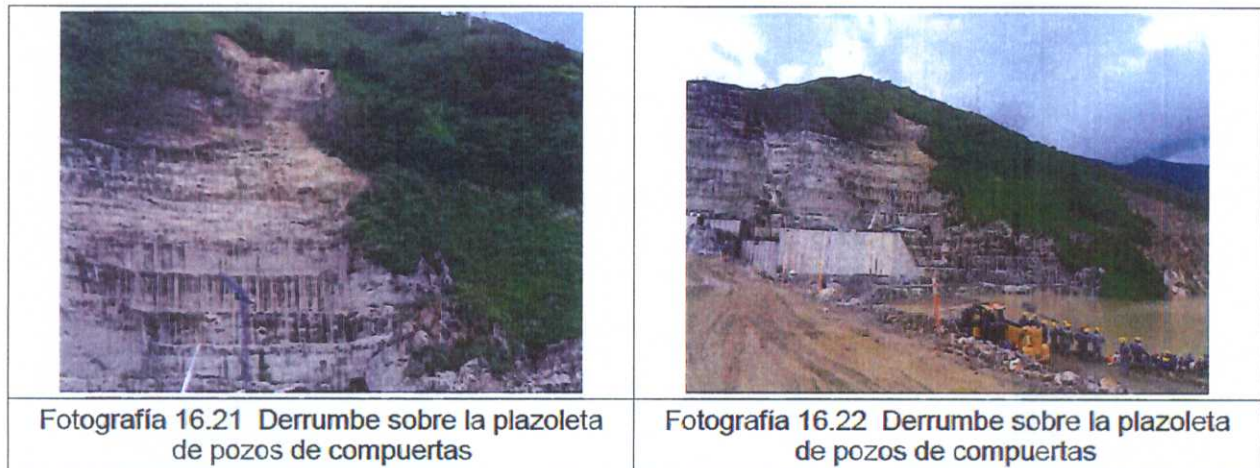
Figure 50. The “Romerito” landslide above the Gate Chamber on May 26, 2018²⁴⁰

9.28. Gates 7 and 8 from the Gate Chamber were closed between 15:10 and 15:30 hrs. on May 26, 2018, taking about 12 minutes each, in sequence²³⁸. At 17:00 hrs. on May 26, 2018 there was a landslide referred to as the “Romerito” in the slope above the same gates 7 and 8 (Figure 50, Figure 51). This landslide was associated with distortion and cracking of the support of the Tunnel Vial. There is a record of a release of energy from the local seismographs at 17:07 hrs. on May 26, 2018²³⁹.
