**ITUANGO HYDROELECTRIC POWER PLANT
COLLAPSE OF THE AUXILIARY DIVERSION TUNNEL
CONSTRUCTION ALL RISK POLICY No. 2901211000362
ROOT CAUSE ANALYSIS**

August 2, 2019

Subject Matter: This root cause report pertains to the Ituango Hydroelectric Power Plant, Antioquia, Colombia, that was under construction when the Auxiliary Diversion Tunnel collapsed. The event was recorded as April 28 to 30, 2018.

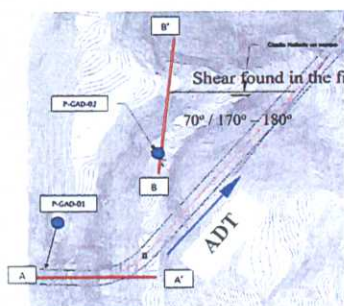
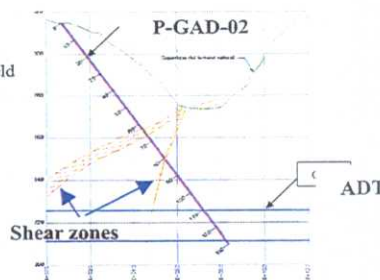
Figure 10. Location of P-GAD-02 and shear zone found in the field mapping⁴⁴ and interpreted shear zones⁴⁵.

- 6.3. A shear zone was mapped in the Tenche river valley⁴³ during the construction work orientated at 70° / 170° to 180° which was further investigated by a borehole P-GAD-02 in March 2016. Figure 10, Figure 11 and Figure 12 show the location of the borehole P-GAD-02 and the alignment of the ADT, the geological cross section with the projection of the shear zones identified in the borehole to the ADT tunnel horizon, and the photographic record of the shear zone in borehole P-GAD-02 as it reaches the excavation of the ADT. This is the shear zone that is at the location of the collapse.

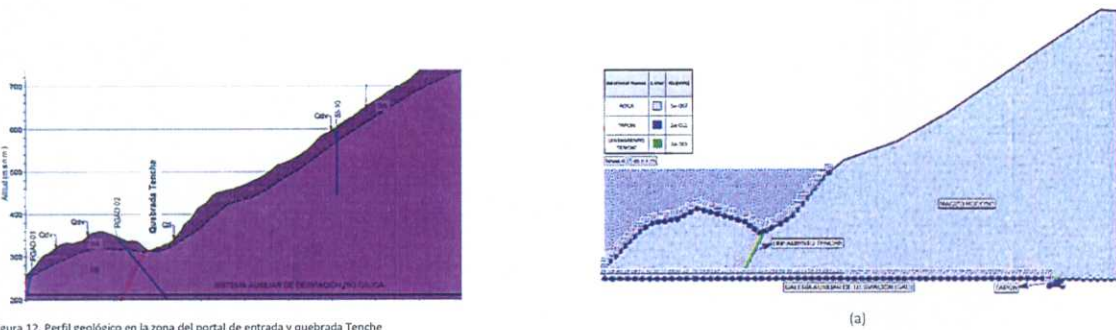
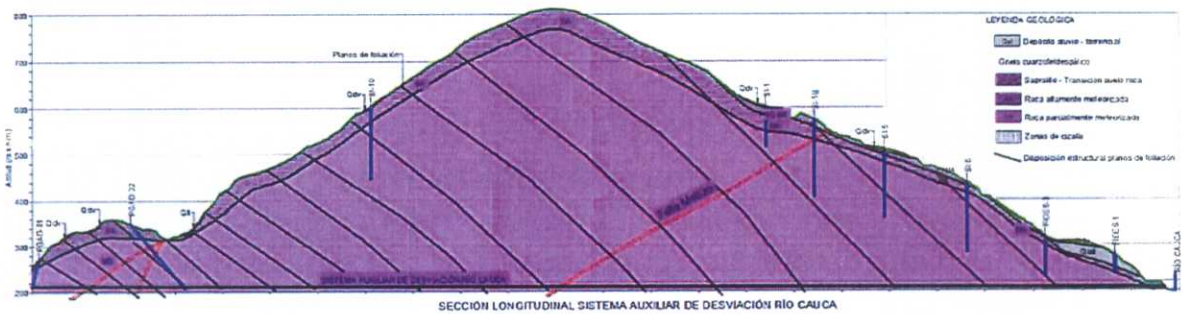
Figure 14. Geological Profile in the ADT portal area, 2018^{62,63} and 2017⁶⁴

6.11. A geological ‘profile’ was prepared for the ADT in the ‘portal area’. The version presented in the 2018 Geotechnical memorandum was simplified compared to a version dated 2016 that was referenced in a hydrogeological study carried out in 2017 because only one shear zone was shown in the Tenche valley area. The simplified version appears to have also been used in the groundwater model used as part of the 2018 ADT “*lining design requirement*” study⁶².

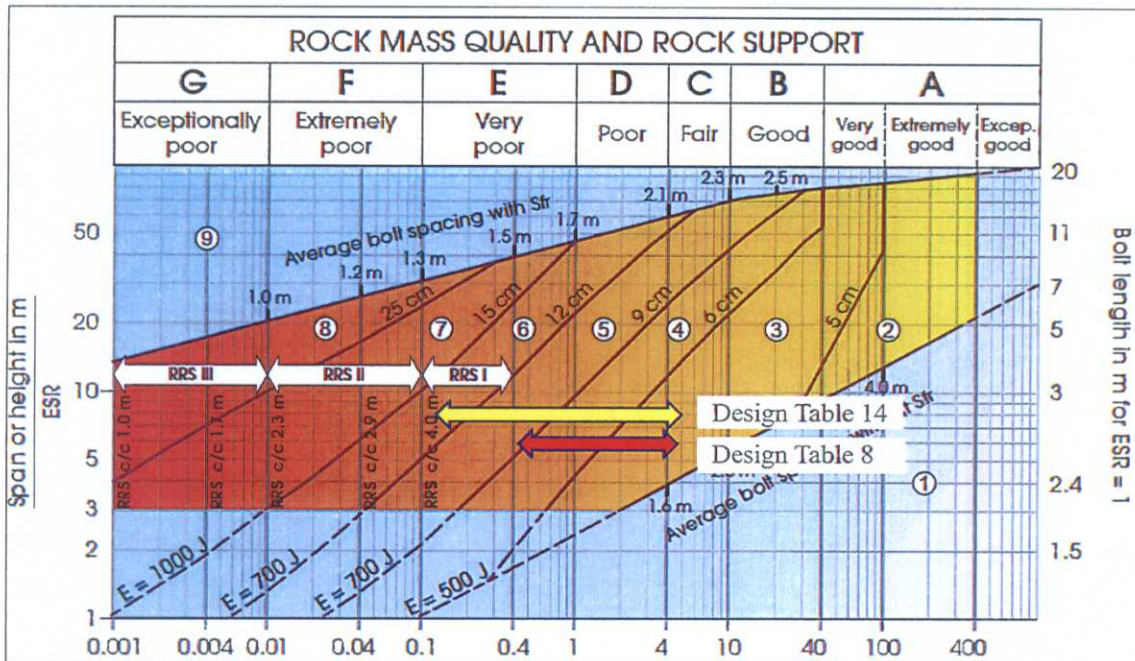
Figure 17. Q-Method design chart – range of values for terrain type III Sector 2 ADT.

7.19. The consequence of this difference is illustrated below for terrain type III which shows that the Q value ranges could produce two possible support recommendations when applied to the Q method chart, depending which of the sources from Table 6 is used.

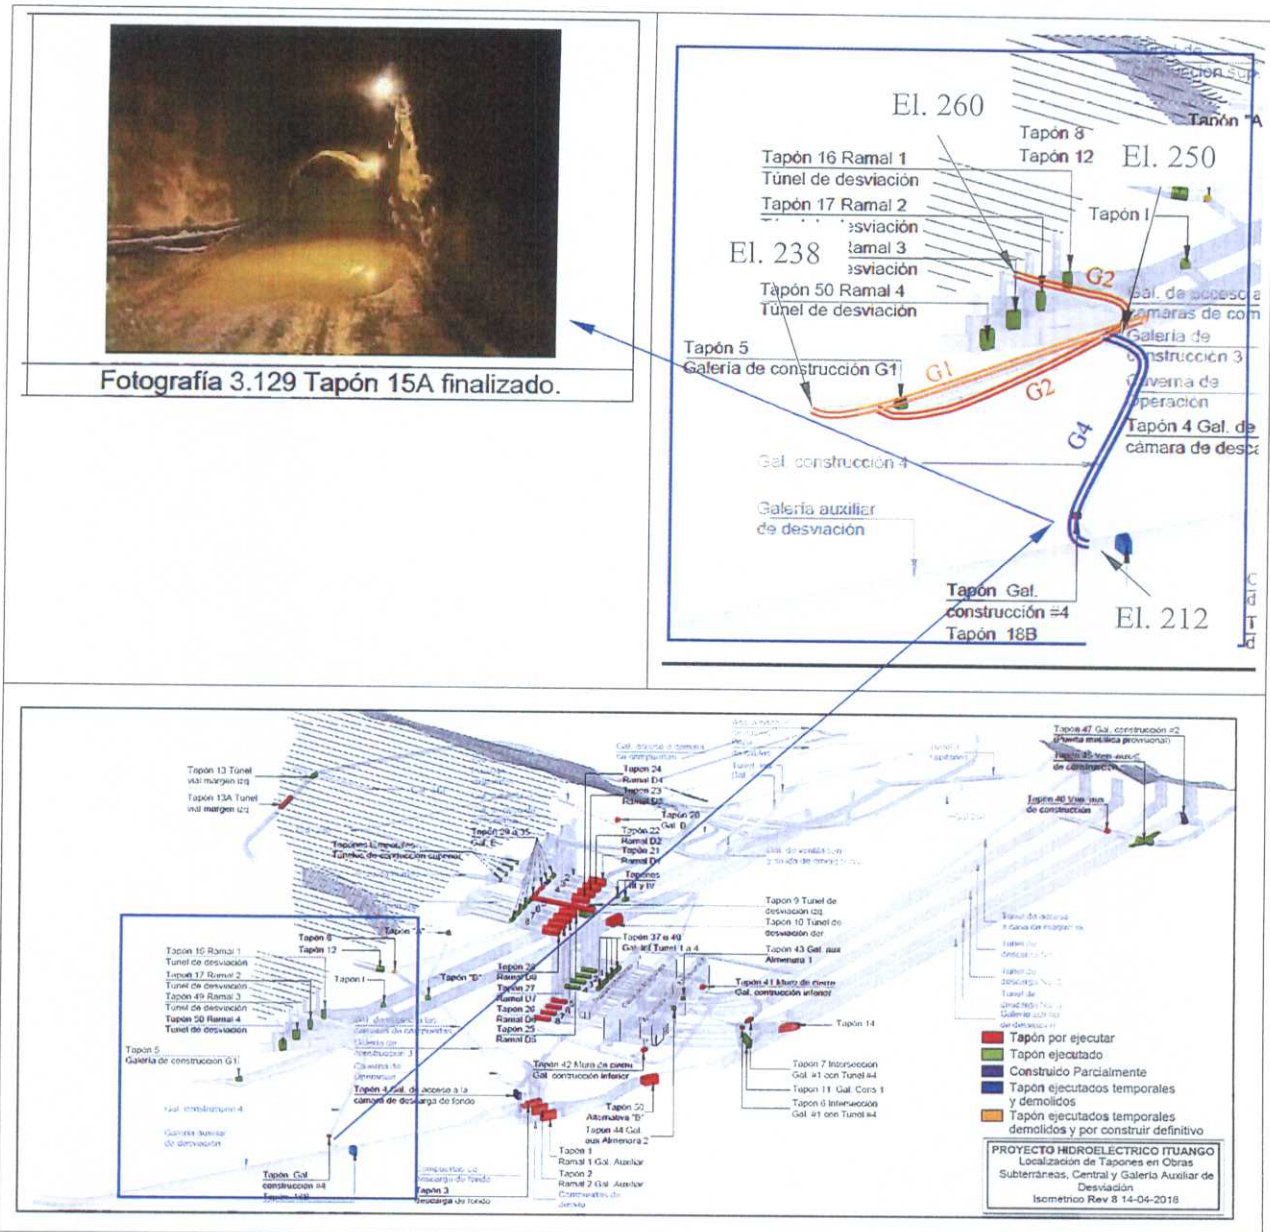
Figure 27. Location of concrete barrier (Tapón 15A)^{185,186}. Elevations are at invert¹⁸⁷.

The location of Tapón 15A is shown in Figure 27. The as built record refers to this as a “perforated wall”¹⁸³ and the drawing shows drainage tubes passing through it¹⁸⁴.

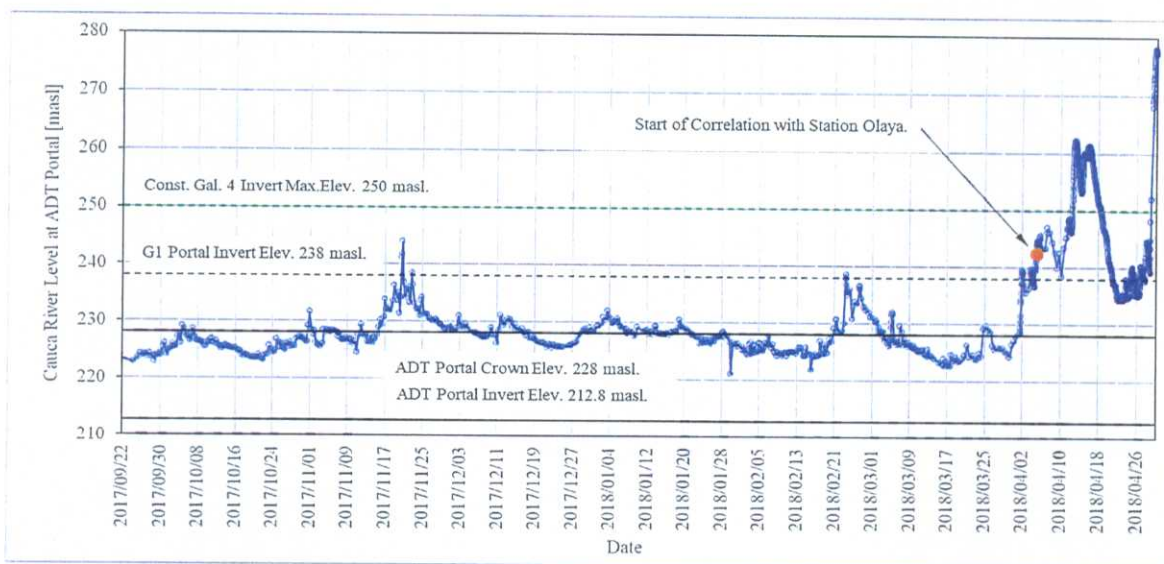
Figure 28. River Level at ADT upstream portal, measured and estimated¹⁸⁹

8.41. River level at the ADT portal was measured at Puente Pescadero with varying frequency until April 5, 2018 and estimated from measurements at Station Olaya about 70 km upstream thereafter (Figure 28). The measurements were stopped due to a rise in the river level inundating the station. The upstream portal of Construction Gallery No. 1 connects to the reservoir at elevation 238 masl, then connects to Construction Gallery No. 2 and connects to Construction Gallery No. 4 at elevation 250 masl, which then connects to the ADT at elevation 214 masl. The elevations of the Construction Galleries No. 1, No. 4 and the river level during operation of the ADT are shown in Figure 28. The river reached the ADT through construction galleries No. 1, No. 2 and No. 4 between April 12, 2018 and April 18, 2018 when the river level surpassed elevation 250 masl. However, the design of the ADT was for water flow through the main tunnel only, and for a design flood with a 50-year return period, which corresponds to a river level 352.8 masl¹⁸⁸.

design drawings of the ground reinforcement at the ADT portal¹⁹¹ to the photographic record. The composite on Figure 29 indicates the reservoir level on the days prior to April 28, 2018 was about Elev. 234 - 235 masl, which coincides with the data from Figure 28, and is 6 to 7 m above the crown of the ADT portal. The floating tree logs at this minimum reservoir level are above the crown of the ADT portal, and the reservoir level did not drop below the crown (Figure 28) such that floating logs could enter the tunnel. Furthermore, there are no records provided of failure of the mesh at the time allowing tree logs to flow rapidly and in large quantities into the ADT.

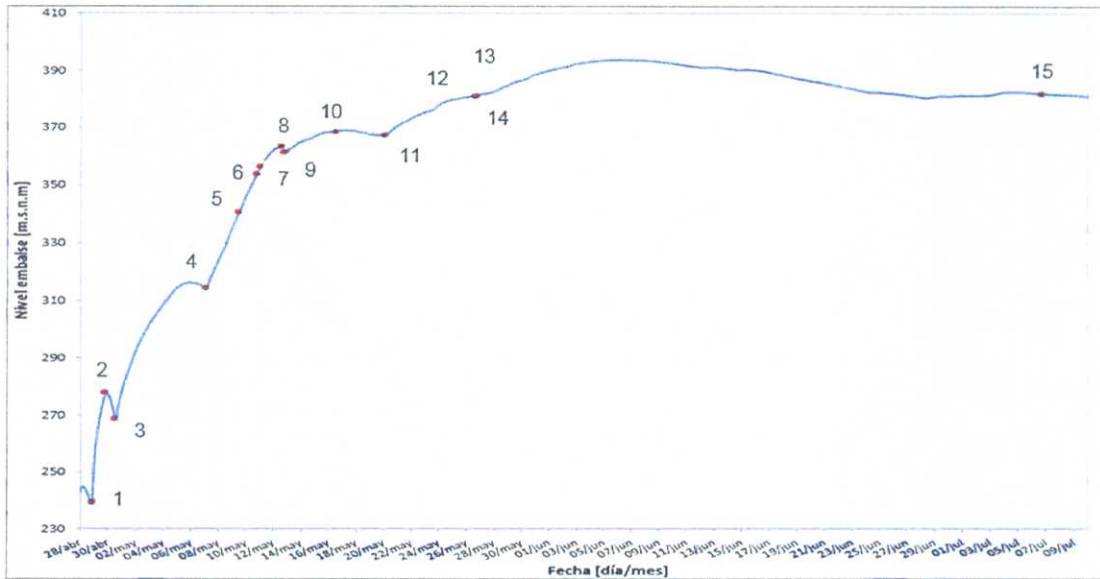
Figure 32. Graphical presentation of the sequence of events against the reservoir level

9.3. A summarized sequence of events (Figure 31), the changes in reservoir level (Figure 32) and the flow conditions (Figure 33) was presented in the Asesoría report of January 2019.¹⁹³

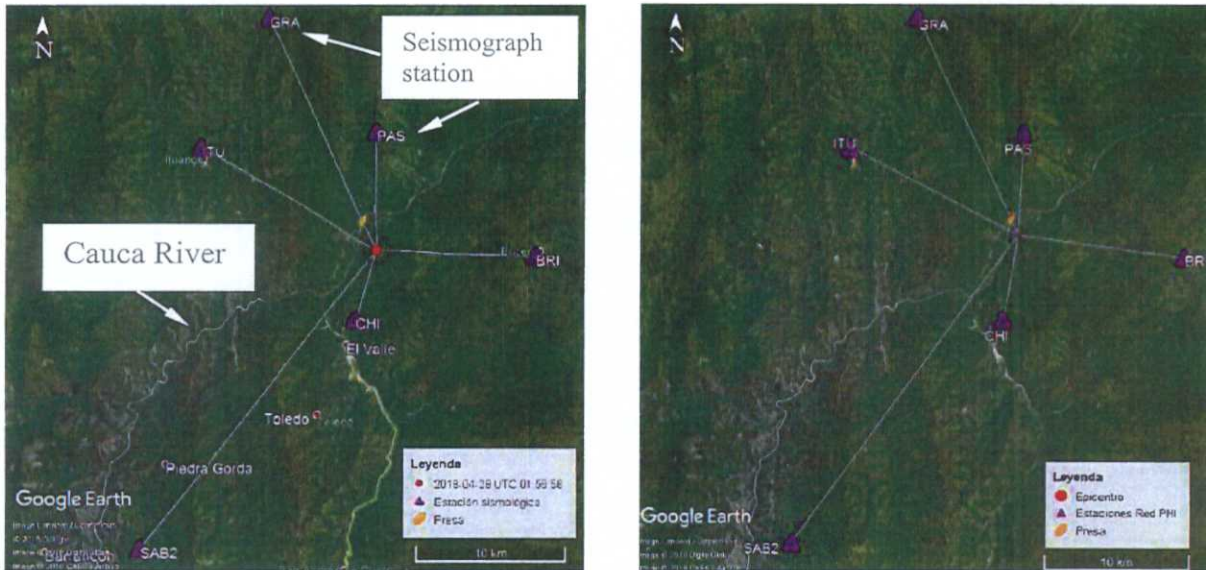
9.6. The seismographs installed by the Project reacted to a release of energy at 20:56 and 20:57 on April 28, 2018. The signal was interpreted to be too weak for an earthquake and it was concluded by the Asesoría that it was related to a collapse of the ADT.

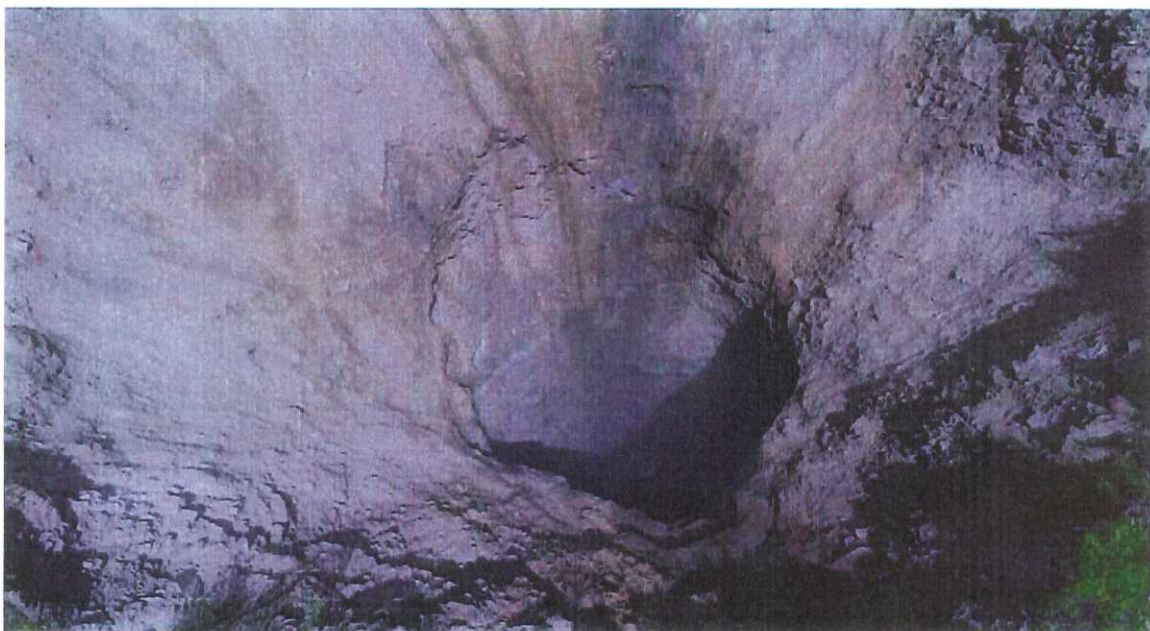
100 m in diameter narrowing to about 12m in its interior appeared at the ground surface above the ADT²¹⁰ (Figure 37, Figure 38, Figure 39²¹¹). Reservoir levels began to rise from 13:00 hrs. onwards.

Fotografía 2. Vista interna del desprendimiento

Figure 38. Close up photograph of interior of sinkhole

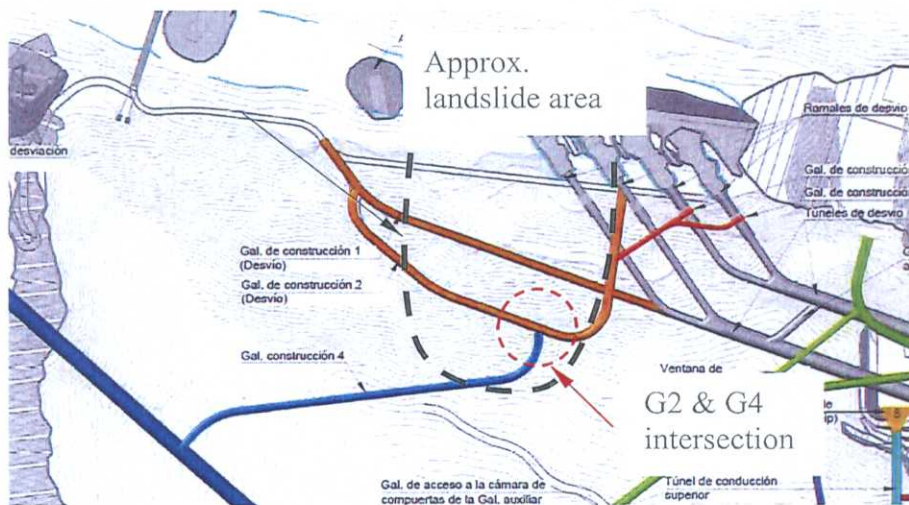
9.19. On the morning of May 9, 2018, there was a considerable increase in flow from the exit portal of the RDT²²⁰ and a release of energy was recorded at 12:06 hrs. At 16:30 hrs. there was another landslide on the right riverbank that blocked flow through that tunnel resulting in rising reservoir levels at a rate of 0.91 m/hour (Figure 43)²²¹. A chimney appeared near the intersection of Galleries 2 (Asesoría refers to G1) and 4²²¹, (Figure 43 and Figure 44). Flow measured downstream at Pte. Valdivia increased from 236 m³/s at 14:30 hrs. on May 9, 2018 to a peak of 875 m³/s by 16:00 hrs., before falling again to 260 m³/s by 21:30 hrs. of the same day.

Figure 44. Area of landslide and sinkhole above Galleries 2 and 4.²²³

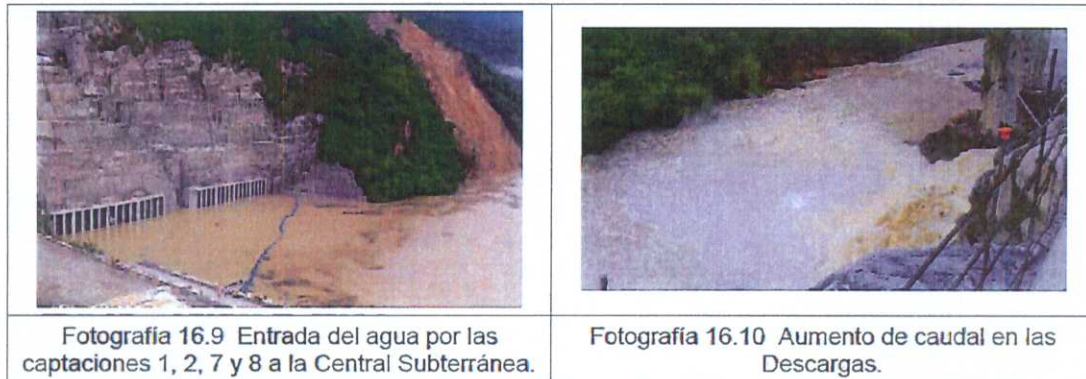
three tunnels increased (Figure 45)²²⁴. The reservoir level at the time of this diversion was 353.74 masl continuing to rise to 356.42 masl at 02:00 hrs. on May 11, 2018.

Figure 45. Photographs showing the conditions on May 11, 2018²²⁵

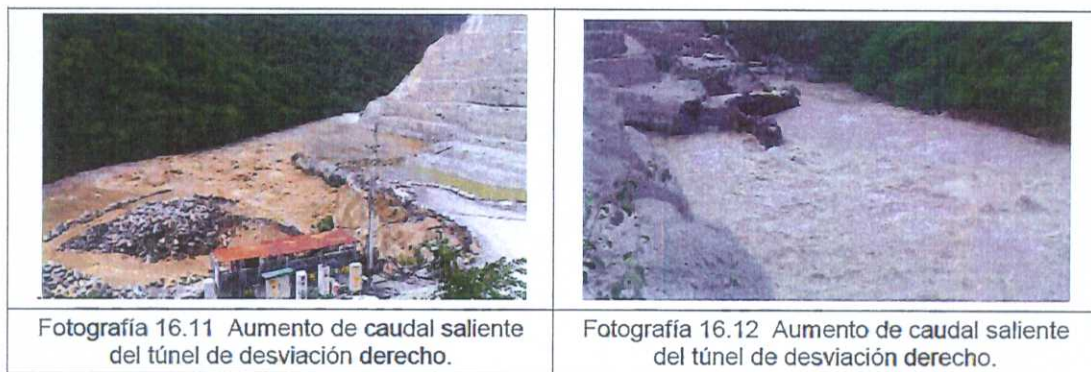
9.21. At 15:30 hrs. on May 12, 2018, it was reported that there was an increase in flow from the exit portal of the RDT reaching a peak of about 5,000²²⁶ or 6,000 m³/sec²²⁷ and the reservoir level which had reached 362.56 masl began to decrease rapidly to 361.36 masl (Figure 46). This flow was again blocked by a further movement of material from the previous landslide area and reservoir levels again began to increase²²⁷. Also, a release of energy was recorded by the local seismographs at 18:10 hrs. on May 12, 2018.²²⁸ Flow measured downstream at Pte. Valdivia reached a peak of 6,025 m³/s at 18:45hrs. on May 12, 2018.

Figure 46. Photographs supporting observation of increase flow May 12, 2018²²⁹ .

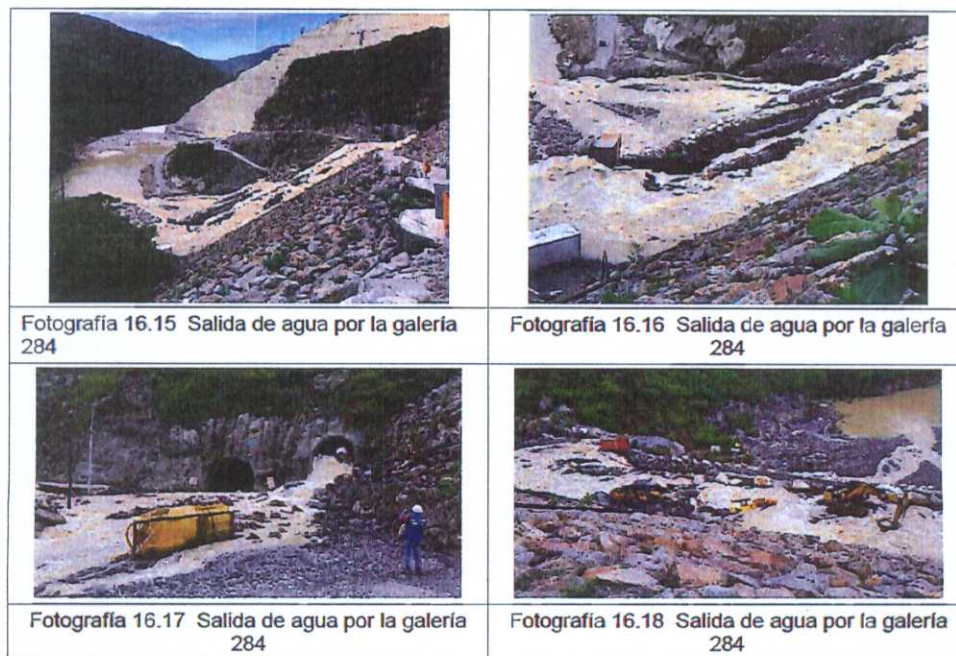
9.22. On the morning of May 16, 2018, damage was found at the exit canal of Discharge Tunnel 3 due to the force of water flow. At 11:10 hrs. water was recorded flowing from the Main Access Tunnel to the Powerhouse and at about mid-day from Galleria 284 (Figure 47) with air flow²³⁰ as well as a reduction in flow from the outlet portal of Discharge Tunnel 3, from a blockage.²³¹ A release of energy was recorded at 12:07 hrs. on May 16, 2018.²³²

Figure 48. Photographs of the events at Galleria 284 May 16, 2018²³³

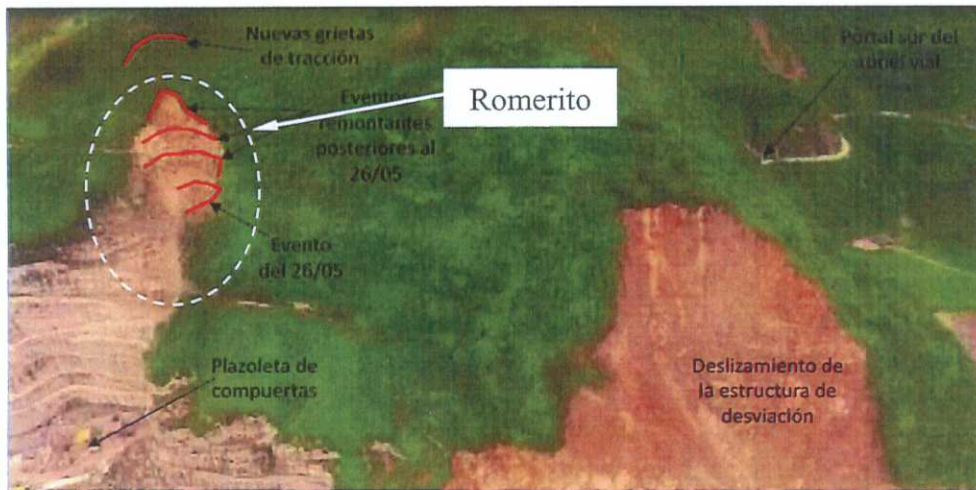
9.28. Gates 7 and 8 from the Gate Chamber were closed between 15:10 and 15:30 hrs. on May 26, 2018, taking about 12 minutes each, in sequence²³⁸. At 17:00 hrs. on May 26, 2018 there was a landslide referred to as the “Romerito” in the slope above the same gates 7 and 8 (Figure 50, Figure 51). This landslide was associated with distortion and cracking of the support of the Tunnel Vial. There is a record of a release of energy from the local seismographs at 17:07 hrs. on May 26, 2018²³⁹.

Figura 4-1. Panorámica de la ladera derecha del proyecto (fecha aproximada de la foto 28/05/2018)

Figure 51. Photograph showing the Romerito and the landslide above the deviation tunnel intakes²⁴¹

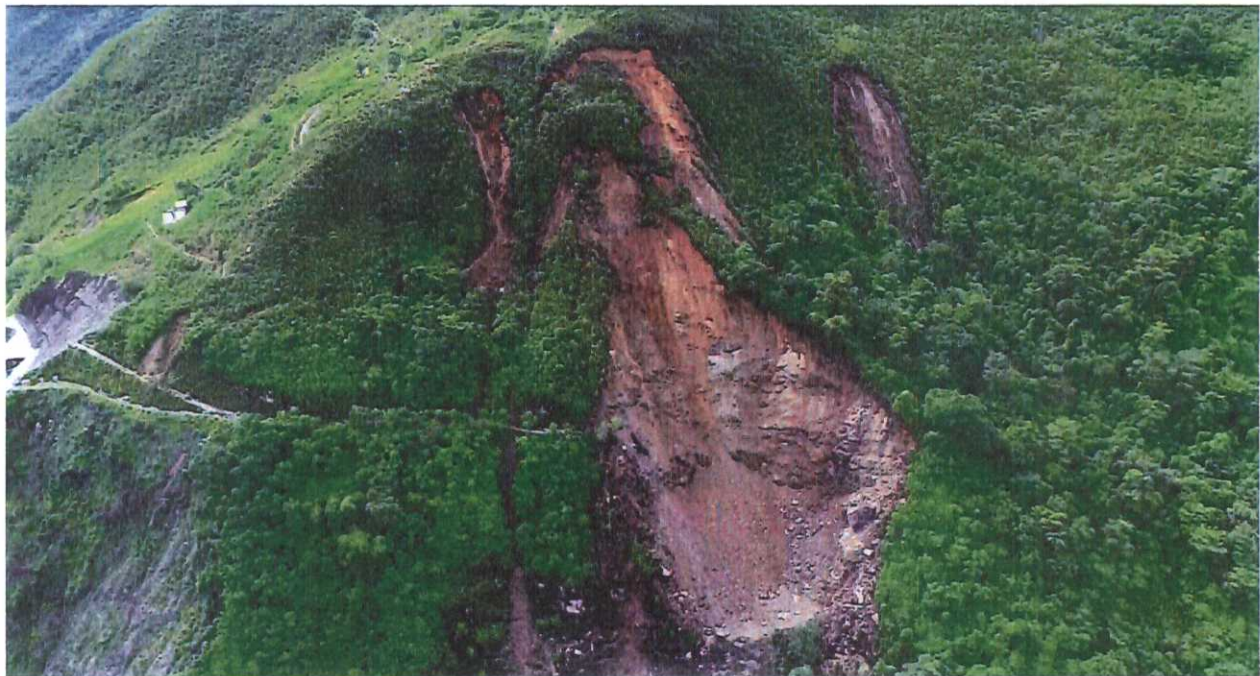
- 9.26. On the morning of May 21, 2018 the landslides above the diversion tunnel intakes and above the Gate Chamber Platform re-activated and cracks formed in the Gate Chamber (Gates 5 to 8) and the associated Construction Galleries (Figure 49)²³⁴ and water continued to flow through the RDT outlet portal at about 50 m³/sec²³⁶.

Fotografía 4-1. Parte alta de la Plazoleta de Compuertas (junio 10/2018)

Figure 52. Close up photograph June 10, 2018 of the landslide above the Gate Chamber²⁴²
